RE: Dune Walkways & Crossovers
Various Locations
North & South Fletcher Avenue
Fernandina Beach, Florida

Situation: Beach Access Walkways
Preliminary Assessment
City of Fernandina Beach, Florida

Jobsite: Beach Access Walkways
North and South Fletcher Avenue
Fernandina Beach, FL 32034

Date: March 15, 2019

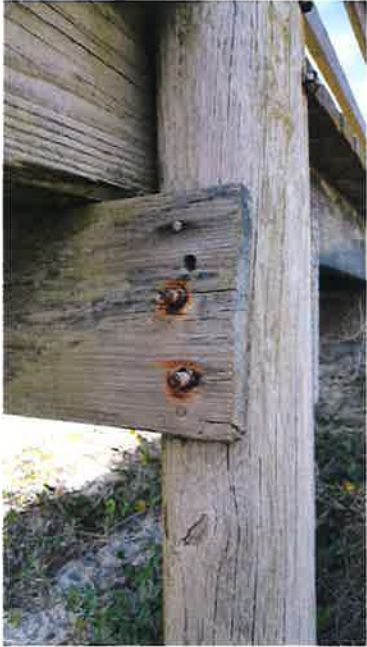
Boardwalk systems ranked as a four (4) or five (5) suffer from connector degradation due to corrosion, along with repairs required for the deck, supports and/or railing system. Most have experienced significant nut, washer and bolt head corrosion such that some connections have completely corroded apart. These damage connectors are also associated with the guardrail system. These deficient connectors and gravity carrying members would qualify as suffering substantial structural damage as defined in Section 2.2 above. Therefore, those sections would need to be repaired or replaced as soon as possible.

Corroded Bolts and Nuts at Girder

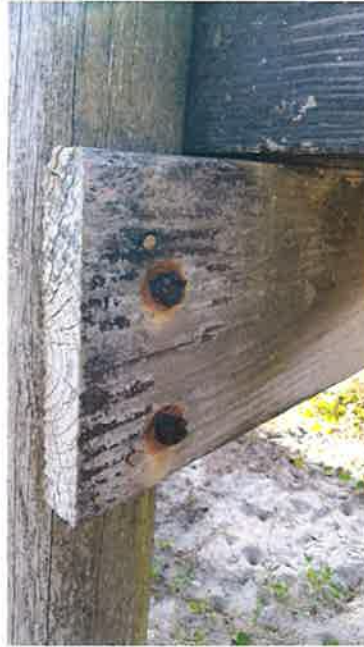
Corroded Bolt Heads at Girder

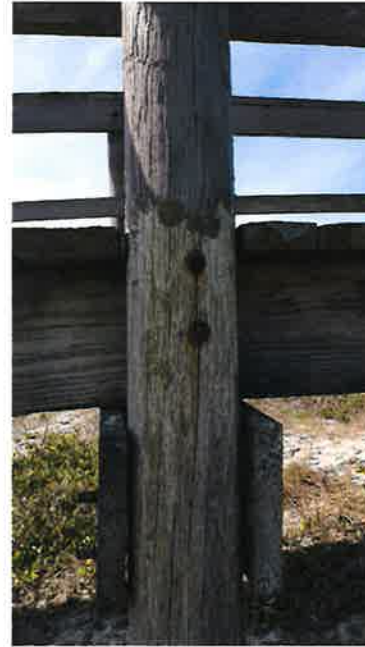
Corroded Bolt Heads at Joist to Piling

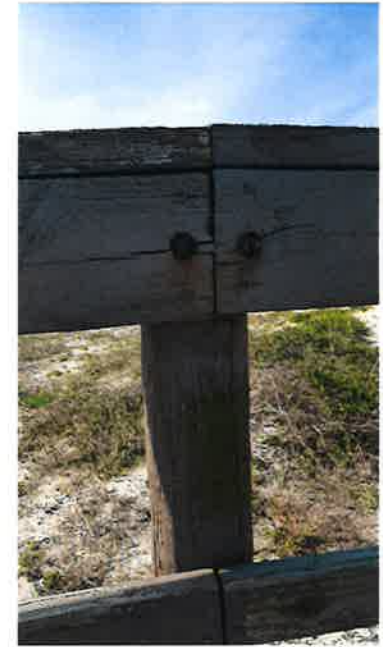
Corroded Bolt Heads at Guardrail to Piling
