RE: Dune Walkways & Crossovers  
Various Locations  
North & South Fletcher Avenue  
Fernandina Beach, Florida

Situation: Beach Access Walkways  
Preliminary Assessment  
City of Fernandina Beach, Florida

Jobsite: Beach Access Walkways  
North and South Fletcher Avenue  
Fernandina Beach, FL 32034

Date: March 15, 2019

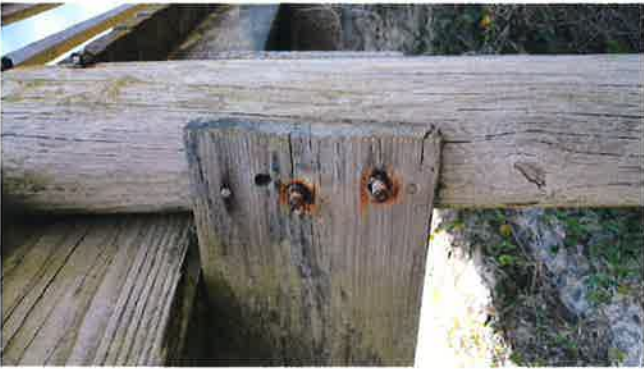
Boardwalk systems ranked as a four (4) or five (5) suffer from connector degradation due to corrosion, along with repairs required for the deck, supports and/or railing system. Most have experienced significant nut, washer and bolt head corrosion such that some connections have completely corroded apart. These damage connectors are also associated with the guardrail system. These deficient connectors and gravity carrying members would qualify as suffering substantial structural damage as defined in Section 2.2 above. Therefore, those sections would need to be repaired or replaced as soon as possible.

Corroded Bolts and Nuts at Girder

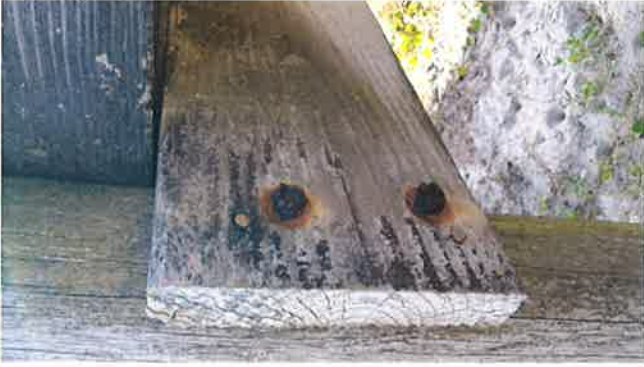
Corroded Bolt Heads at Girder

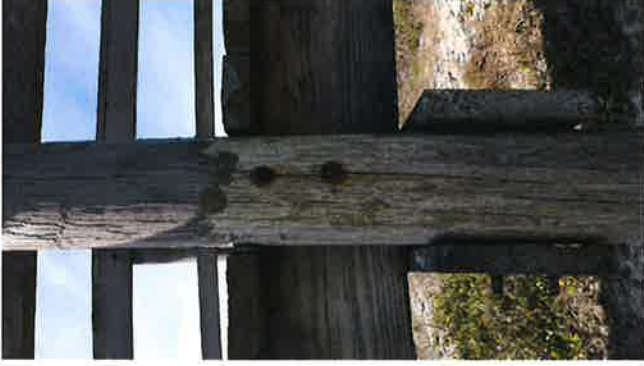
Corroded Bolt Heads at Joist to Piling

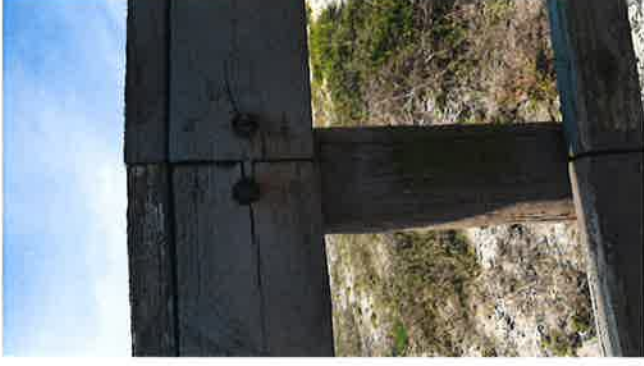
Corroded Bolt Heads at Guardrail to Piling
